**Flood Control Project Maintenance
Levee Inspections**

Maintenance Issue Types Only, Levee Inspection Report By Mile - Spring 2019

Tehama County Flood Control and Water Conservation District

Waterway	Bank	Unit Miles	Inspection Start/End	Inspector
Unit No. 01 Deer Creek	Left	4.22	05/01/2019 05/01/2019	Makar Sokol

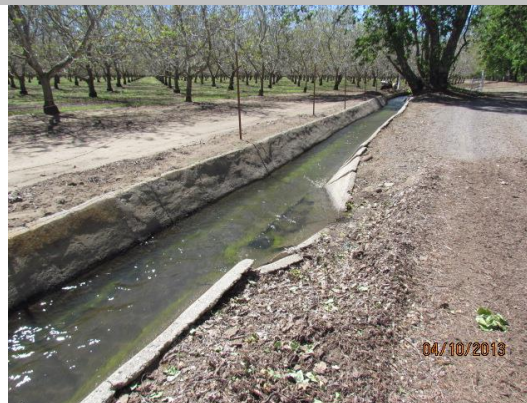
Photo 1 of 1 : SP_2019_NA0019_78_19_20190327_00007.jpg

LM Start	0.46	Rating **	M	Issue No.	19
LM End	0.46	Issue Type +	Ma	Location *	LS
Category	Earthen Levee			GPS Latitude/Longitude	
				Start	End
Item	Erosion / Bank Caving			39.972339 °	39.972339 °
				-121.988763 °	-121.988763 °
DWR ID	DWR_NA0019_01_s_2013_19				
Comment Code					
E2 : Schedule repair of erosion site prior to the next inspection.					
Inspector Comment

View of the erosion along the landside slope.

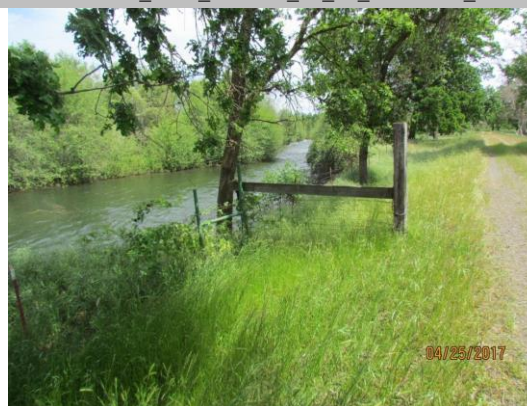
Photo 1 of 2 : SP_2019_NA0019_78_42_20190327_00016.jpg

LM Start	1.55	Rating **	A/W	Issue No.	42
LM End	1.58	Issue Type +	Ma	Location *	WS
Category	Earthen Levee			GPS Latitude/Longitude	
				Start	End
Item	Erosion / Bank Caving			39.969193 °	39.969052 °
				-122.008458 °	-122.008920 °
DWR ID	DWR_NA0019_01_s_2017_42				
Comment Code					
E2 : Schedule repair of erosion site prior to the next inspection.					
Inspector Comment

View of the erosion along the waterside toe.

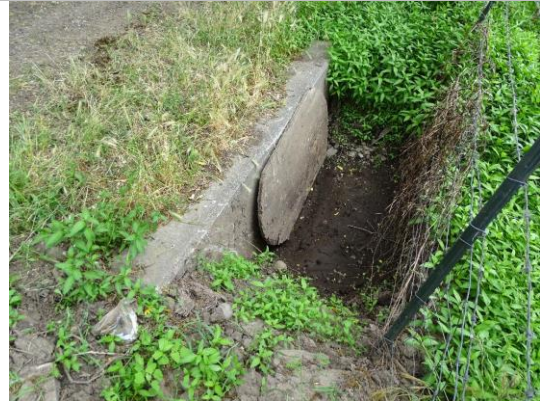
Photo 1 of 3 : UCIP_SP_2019_54006_79261.jpg

Comment Code						
Inspector Comment						
FS_ID:54006 DS_ID:20770 EP_NO: N/A Repair Type: Non-Urgent Crossing Status: Found UCIP Comments: 05/14/2019 Pipe end on WS has been cleared from sediment buildup to let flap gate close properly, but the rest of pipe is still silted inside. Flap gate was fixed and operable now. (DWR UCIP - OYakimov)10/15/2018 Flap gate on WS end stuck open. Lower part of pipe is silted that makes impossible flap gate to fully close. Needs sediment cleanup around pipe outlet on WS. (O.Yakimov - DWR)12/05/2016 Sediment buildup inside pipe (see photo) and sediment buildup on WS blocking flap gate. Crossing has been downgraded from Urgent to Non-Urgent crossing was closed on both WS and LS. (O. Magana - DWR UCIP)10/02/2013 Flapgate blocked by soil buildup. (W. Wylie - DWR UCIP) FIELD_STRUCT_DESC: 24-inch steel drainage pipe through the levee, 1.5 feet below the crown. Flap gate on the waterside (WS) toe. [Additional Reference(s): DWR Levee Log, 1992. USACE Sacramento O&M Manual Unit 509, March 1957, As-built drawings available 50-4-2394 (Station 185+40)]. FS Date: 5/14/2019 3:33:54 PM

LS view of concrete headwall with wood panel blocking opening

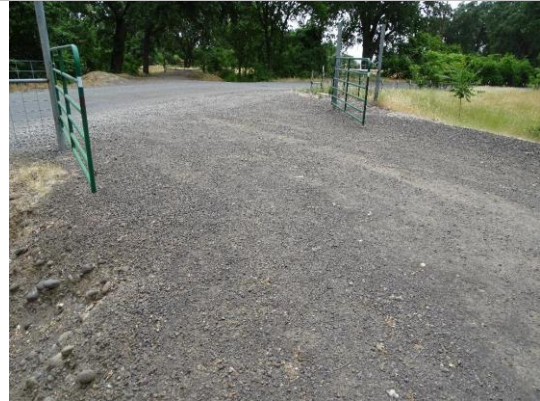
Photo 1 of 3 : UCIP_SP_2019_54008_79270.jpg

Comment Code					
Inspector Comment					
FS_ID:54008 DS_ID:20769 EP_NO: N/A Repair Type: Urgent Crossing Status: Found UCIP Comments: 05/14/2019 No change to the crossing since last inspection. (DWR UCIP - OYakimov)10/15/2018 Flapgate on WS is missing, pipe partially blocked with sediment. (O.Yakimov - DWR)12/05/2016 same as last inspection. Crossing remains "Urgent" WS opened during flood season due to damaged flap gate. (O. Magana - DWR UCIP)10/02/2013 Flapgate missing or buried on WS toe. Pipe partially blocked by soil on WS toe. (W. Wylie - DWR UCIP) FIELD_STRUCT_DESC: 24-inch corrugated metal drainage pipe through the levee, 7 feet below the crown. Flap gate located on the waterside (WS) end. A 5-foot by 5-foot concrete control structure located on the landside (LS) toe. [Additional Reference(s): DWR Levee Log, 1992. USACE Sacramento O&M Manual Unit 509, March 1957, As-built drawing no. 50-4-2394 (Station 176+10)]. FS Date: 5/14/2019 4:05:54 PM

Overview of levee crown where pipe crosses

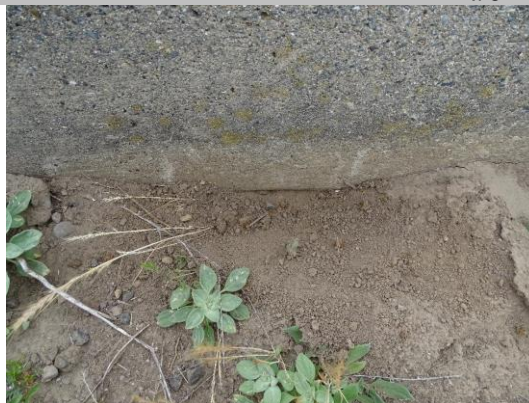
Photo 2 of 3 : UCIP_SP_2019_54011_79273.jpg

Comment Code						
Inspector Comment						
FS_ID:54011 DS_ID:20877 EP_NO: N/A Repair Type: Non-Urgent Crossing Status: Found UCIP Comments: 05/14/2019 Pipe outlet and headwall were excavated to evaluate pipe condition. Pipe is completely filled with soil that makes impossible to clear it for DMP internal video inspection. Pipe may be rehabilitated under DMP Phase II or removed. Excavated soil was backfilled. (DWR UCIP - OYakimov)Headwall covered with soil. Needs to be cleared at both ends. FIELD_STRUCT_DESC: 24-inch corrugated metal pipe through the levee 5-feet below the crown. Calco automatic drainage gate. Originally included in O+M manual (1957). As-built drawings available 50-4-2394. FS Date: 5/14/2019 8:37:31 AM

Concrete headwall on LS toe: top of pipe visible

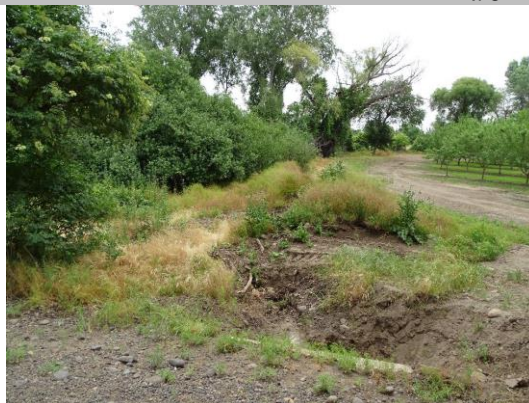
Photo 2 of 3 : UCIP_SP_2019_54012_79277.jpg

Comment Code						
Inspector Comment						
FS_ID:54012 DS_ID:20767 EP_NO: N/A Repair Type: Non-Urgent Crossing Status: Found UCIP Comments: 05/14/2019 Pipe outlet and headwall were excavated to evaluate pipe condition. Discovered a concrete pipe that connects nearby ditch with inlet of this crossing to drain water from the ditch. Cleared pipe outlet at WS toe. (DWR UCIP - OYakimov) Pipe blocked by soil. FIELD_STRUCT_DESC: 24-inch corrugated metal drainage pipe through the levee, 6 feet below the crown. Flap gate on the waterside (WS) end. [Additional Reference(s): DWR Levee Log, 1992. USACE Sacramento O&M Manual 509, March 1957, (Assumed Station 137+50) Drawing No. 50-4-2394]. FS Date: 5/14/2019 9:02:19 AM

View of landside with headwall at the toe

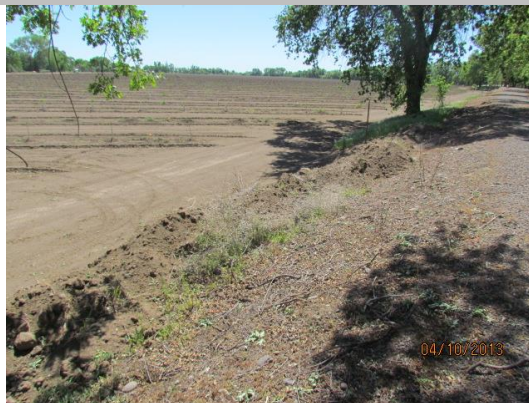
Photo 1 of 1 : SP_2019_NA0019_78_20_20190327_00008.jpg

LM Start	2.88	Rating **	M	Issue No.	20
LM End	2.88	Issue Type +	Ma	Location *	LS
Category	Earthen Levee			GPS Latitude/Longitude	
				Start	End
Item	Slope Stability			39.963709 °	39.963709 °
				-122.030384 °	-122.030384 °
DWR ID	DWR_NA0019_01_s_2013_20				
Comment Code					
S1 : Repair slope instability.					
Inspector Comment

View of the instability along the landside slope.

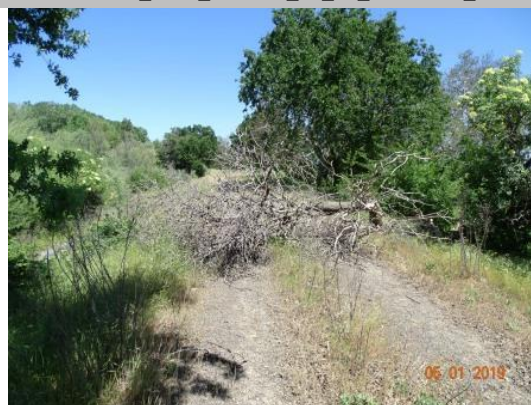
Photo 1 of 1 : SP_2019_NA0019_78_53_20190506_00064.jpg

LM Start	3.40	Rating **	U	Issue No.	53
LM End	3.40	Issue Type +	Ma	Location *	CR
Category	Earthen Levee			GPS Latitude/Longitude	
				Start	End
Item	Encroachments			39.946908 °	39.946908 °
				-122.050770 °	-122.050770 °
DWR ID	DWR_NA0019_01_s_2019_53				
Comment Code					
TR : Tree or limb					
Inspector Comment					
The fallen tree should be removed from the crown.

View of a fallen tree on the crown, blocking the access. Spring 2019.

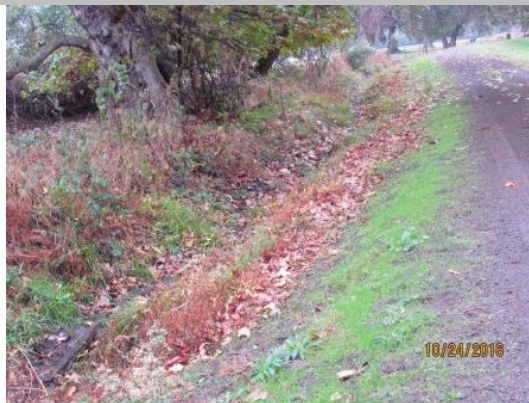
Photo 1 of 1 : SP_2019_NA0019_78_35_20190327_00011.jpg

LM Start	3.58	Rating **	M	Issue No.	35
LM End	3.58	Issue Type +	Ma	Location *	LS
Category	Earthen Levee			GPS Latitude/Longitude	
				Start	End
Item	Vegetation			39.946051 °	39.946051 °
				-122.053985 °	-122.053985 °
DWR ID	DWR_NA0019_01_f_2016_35				
Comment Code					
V2 : Remove the wild growth other than native grasses from the levee slopes.					
Inspector Comment

View of the vegetation along the landside slope and toe.

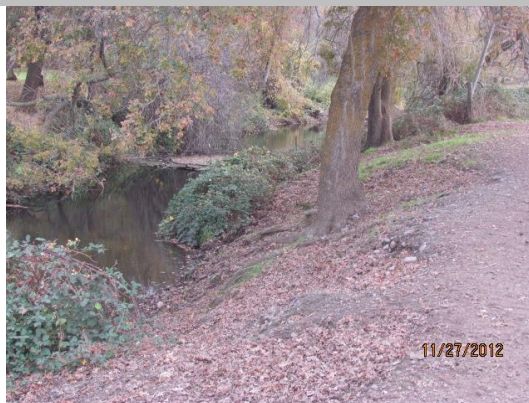
Photo 1 of 1 : SP_2019_NA0019_78_15_20190327_00003.jpg

LM Start	3.68	Rating **	M	Issue No.	15
LM End	3.68	Issue Type +	Ma	Location *	LS
Category	Earthen Levee			GPS Latitude/Longitude	
				Start	End
Item	Slope Stability			39.945045 °	39.945045 °
				-122.053469 °	-122.053469 °
DWR ID	DWR_NA0019_01_f_2012_15				
Comment Code					
S1 : Repair slope instability.					
Inspector Comment

View of the instability caused by livestock along the landside slope.

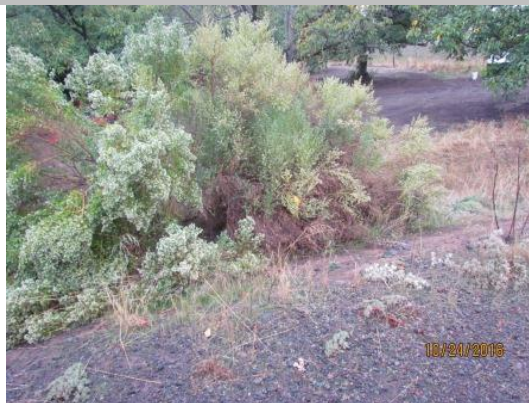
Photo 1 of 1 : SP_2019_NA0019_78_16_20190327_00004.jpg

LM Start	3.75	Rating **	M	Issue No.	16
LM End	3.75	Issue Type +	Ma	Location *	WS
Category	Earthen Levee			GPS Latitude/Longitude	
				Start	End
Item	Vegetation			39.944407 °	39.944407 °
				-122.054104 °	-122.054104 °
DWR ID	DWR_NA0019_01_f_2016_16				
Comment Code					
V2 : Remove the wild growth other than native grasses from the levee slopes.					
Inspector Comment

View of a bush obstructing visibility.

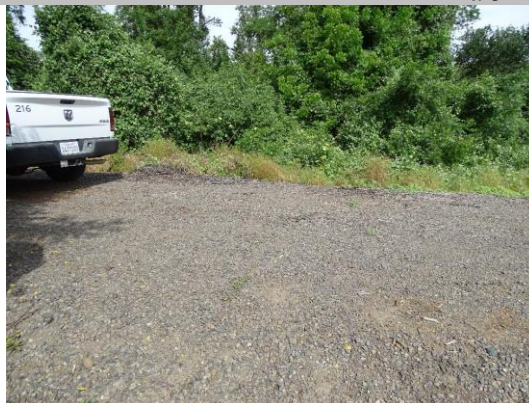
Photo 2 of 3 : UCIP_SP_2019_54023_79299.jpg

LM Start	4.03	Rating **	M	Issue No.	302 (cont)	
LM End	4.03	Issue Type +	Ma	Location *		
Category	Supplemental			GPS Latitude/Longitude		
				Start	End	
Item	DWR UCIP LMA Responsibility			39.941574 °	39.941574 °	
				-122.057597 °	-122.057597 °	
DWR ID	20760					
Comment Code						
Inspector Comment						
FS_ID:54023 DS_ID:20760 EP_NO: N/A Repair Type: Non-Urgent Crossing Status: Found UCIP Comments: 05/14/2019 Crossing is in good condition. (DWR UCIP - OYakimov) FIELD_STRUCT_DESC: 24-inch corrugated metal drainage pipe through the levee, 5 feet below the crown. Flap gate on the waterside (WS) end. Headwalls on both sides of levee. [Additional Reference(s): DWR Levee Log, 1992. USACE Sacramento O&M Manual 509, March 1957, (Assumed Station 5+00) Drawing No. 50-4-2394]. FS Date: 5/14/2019 10:53:58 AM

View of levee crown at the crossing

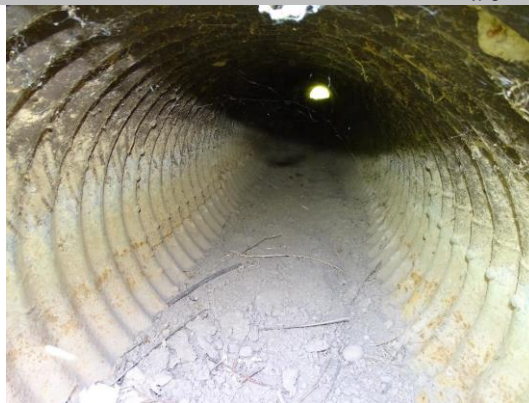
Photo 2 of 3 : UCIP_SP_2019_54024_79305.jpg

Inside view of pipe looking from LS

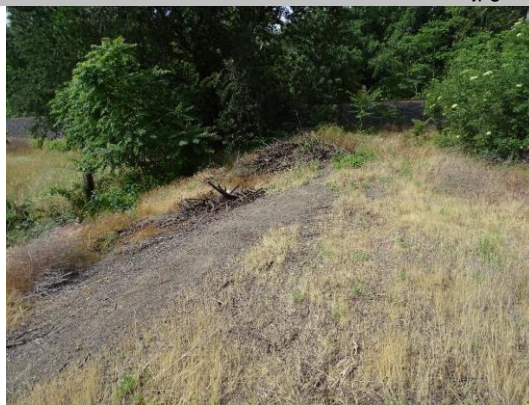
Photo 3 of 3 : UCIP_SP_2019_54024_79303.jpg

View of levee crown at the crossing

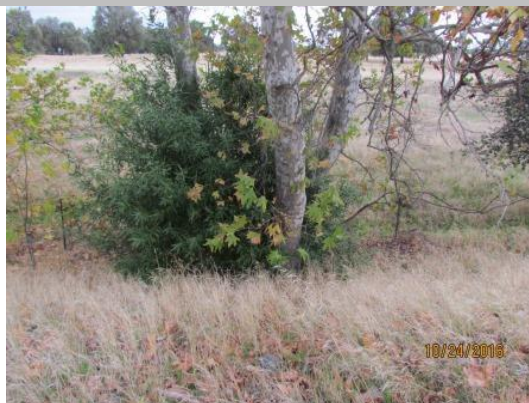
Photo 1 of 1 : SP_2019_NA0019_79_13_20190327_00006.jpg

LM Start	0.23	Rating **	M	Issue No.	13
LM End	0.23	Issue Type +	Ma	Location *	LS
Category	Earthen Levee			GPS Latitude/Longitude	
				Start	End
Item	Trim / Thin Trees			39.970598 °	39.970598 °
				-122.013053 °	-122.013053 °
DWR ID	DWR_NA0019_02_f_2016_13				
Comment Code					
T1 : Trim trees to at least five feet above ground level.					
Inspector Comment					
Remove trees smaller than 4-inches in diameter at chest height.

View of a tree with new thick growth blocking visibility.

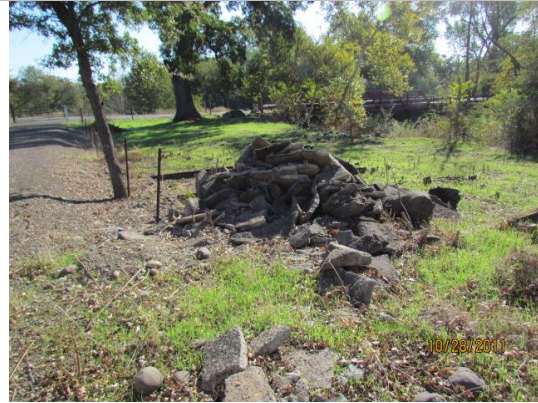
Photo 1 of 1 : SP_2019_NA0019_79_4_20190327_00002.jpg

LM Start	0.34	Rating **	M	Issue No.	4
LM End	0.34	Issue Type +	Ma	Location *	WS
Category	Earthen Levee			GPS Latitude/Longitude	
				Start	End
Item	Encroachments			39.970210 °	39.970210 °
				-122.015198 °	-122.015198 °
DWR ID	DWR_NA0019_02_s_2012_4				
Comment Code					
DE : Debris					
Inspector Comment

View of the concrete pile along the waterside toe.

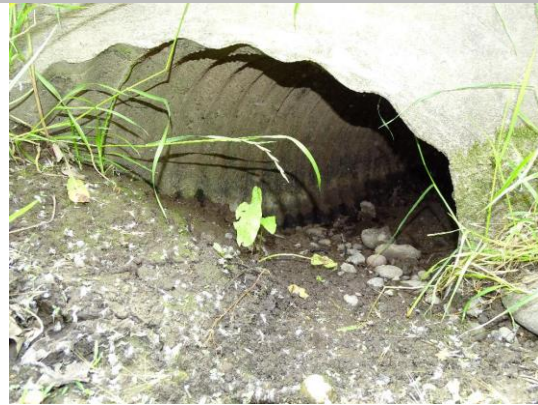
Photo 1 of 3 : UCIP_SP_2019_53997_79240.jpg

Comment Code					
Inspector Comment					
FS_ID:53997 DS_ID:20771 EP_NO: N/A Repair Type: Urgent Crossing Status: Found UCIP Comments: 05/14/2019 Pipe is 50% silted throughout its entire lenght. Flap gate on WS is partially buried in mud that affects proper operation, visible gap between flap gate and pipe. Pipe crosses levee at an angle. (DWR UCIP - O.Yakimov)12/05/2016 Crossing has been downgraded from Urgent to Non-Urgent some debris blocking proper function of flapgate on WS. Recommend clearing debris from WS for flapgate to function properly. (O. Magana - DWR UCIP)10/01/2013 Debris blocking proper function of flapgate on WS toe. (W. Wylie - DWR UCIP) FIELD_STRUCT_DESC: 24-inch steel drainage pipe through the levee, 8.3 feet below the crown. Flap gate located on the waterside (WS) end. Concrete headwall located on the landside (LS). [Additional Reference(s): DWR Levee Log, 1992. USACE Sacramento O&M Manual Unit 509, March 1957, Unit 510, April 1963, Unit 511, May 1973, Unit 512, March 1964, Unit 513, December 1970, As-builts drawing 50-4-2394 (Station 155+40)]. FS Date: 5/14/2019 1:15:18 PM

View of pipe from LS

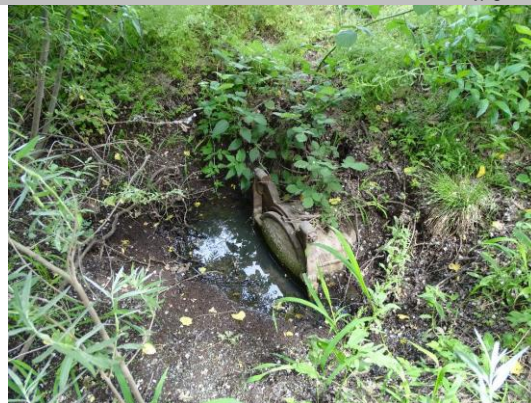
Photo 2 of 3 : UCIP_SP_2019_53997_79241.jpg

Flapgate on WS outlet

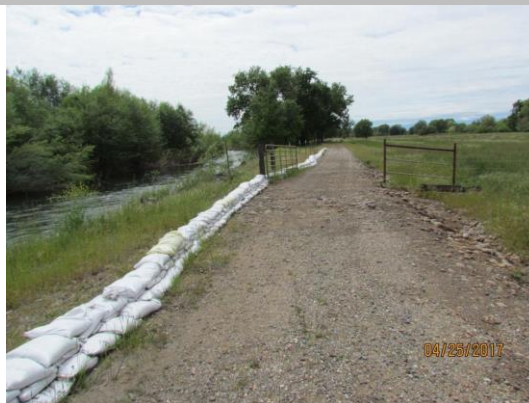
Photo 1 of 1 : SP_2019_NA0019_79_12_20190327_00005.jpg

LM Start	0.81	Rating **	M	Issue No.	12
LM End	0.85	Issue Type +	Ma	Location *	CR
Category	Earthen Levee			GPS Latitude/Longitude	
				Start	End
Item	Erosion / Bank Caving			39.968530 °	39.968248 °
				-122.023305 °	-122.023900 °
DWR ID	DWR_NA0019_02_s_2017_12				
Comment Code					
E2 : Schedule repair of erosion site prior to the next inspection.					
Inspector Comment					
Repair the crown roadway.

View of the erosion on the crown roadway.

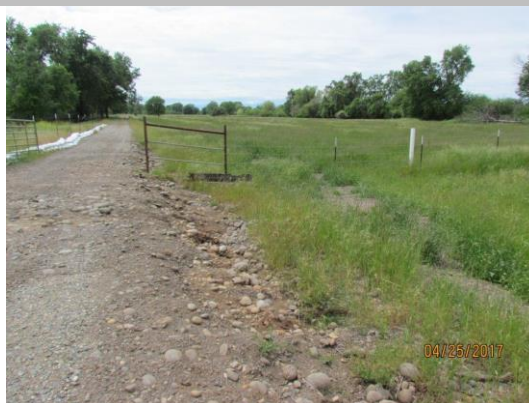
Photo 1 of 1 : SP_2019_NA0019_79_17_20190327_00008.jpg

LM Start	0.81	Rating **	M	Issue No.	17
LM End	0.85	Issue Type +	Ma	Location *	LS
Category	Earthen Levee			GPS Latitude/Longitude	
				Start	End
Item	Erosion / Bank Caving			39.968530 °	39.968248 °
				-122.023305 °	-122.023900 °
DWR ID	DWR_NA0019_02_s_2017_17				
Comment Code					
E2 : Schedule repair of erosion site prior to the next inspection.					
Inspector Comment					
Repair the erosion along the landside slope.

View of the erosion along the landside slope.

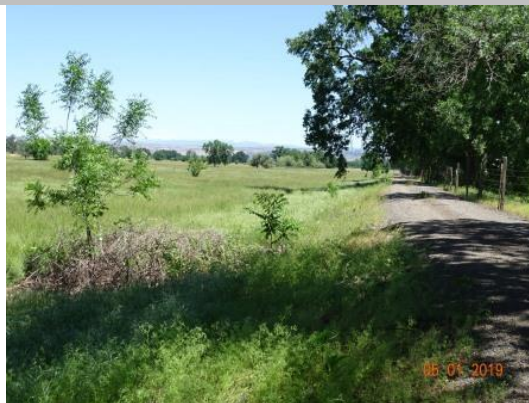
Photo 1 of 1 : SP_2019_NA0019_79_8_20190506_00015.jpg

LM Start	1.28	Rating **	M	Issue No.	8
LM End	1.28	Issue Type +	Ma	Location *	LS
Category	Earthen Levee			GPS Latitude/Longitude	
				Start	End
Item	Trim / Thin Trees			39.964871 °	39.964871 °
				-122.030584 °	-122.030584 °
DWR ID	DWR_NA0019_02_s_2019_8				
Comment Code					
T2 : Thin trees to allow visibility of the ground and room to flood fight.					
Inspector Comment					
Trees four inches in diameter or less at the chest height should be removed from the landside toe.

View of small trees at the landside toe. Spring 2019.

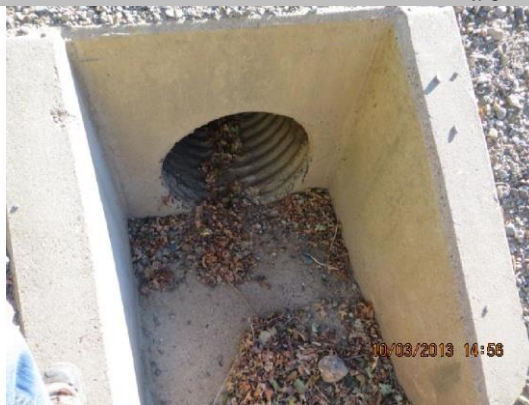
Photo 2 of 3 : UCIP_SP_2019_21795_37073.jpg

Concrete U-shaped headwall on LS toe.

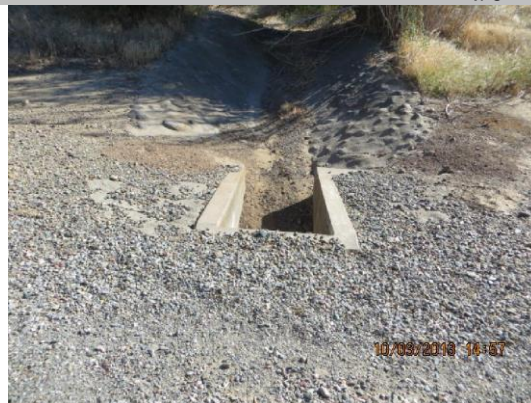
Photo 3 of 3 : UCIP_SP_2019_21795_37072.jpg

LM Start	0.25	Rating **	A/W	Issue No.	917 (cont)	
LM End	0.25	Issue Type +	Ma	Location *		
Category	Supplemental			GPS Latitude/Longitude		
				Start		End
Item	DWR UCIP LMA Responsibility			40.051604 °		40.051604 °
				-122.184431 °		-122.184431 °
DWR ID	20775					
Comment Code						
Inspector Comment						
FS_ID:21795 DS_ID:20775 EP_NO: N/A Repair Type: No Action Needed Crossing Status: Found UCIP Comments: FIELD_STRUCT_DESC: 24-inch corrugated metal drainage pipe through the levee, 4 feet below the crown. Flap gate and concrete U-shaped headwall on the waterside (WS) end. Concrete U-shaped headwall on the landside (LS) end. [Additional Reference(s): DWR Levee Log, 1992. USACE Sacramento O&M Manual 510, April 1963, (HLM 0.26) Drawing No. 50-4-3622]. FS Date: 10/3/2013

Concrete U-shaped headwall on WS toe.

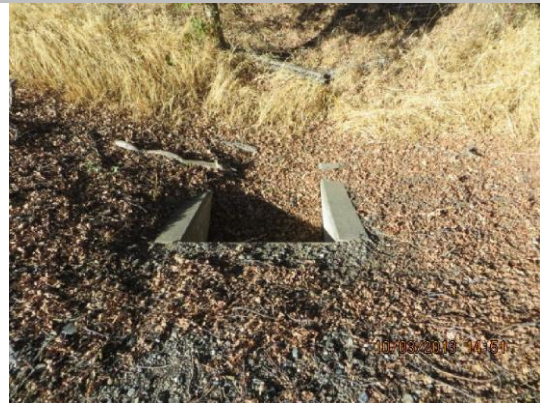
Photo 1 of 3 : UCIP_SP_2019_22826_38961.jpg

LM Start	0.38	Rating **	A/W	Issue No.	918
LM End	0.38	Issue Type +	Ma	Location *	
Category	Supplemental			GPS Latitude/Longitude	
				Start	End
Item	DWR UCIP LMA Responsibility			40.051572 °	40.051572 °
				-122.182093 °	-122.182093 °
DWR ID	20776				
Comment Code					
Inspector Comment					
FS_ID:22826 DS_ID:20776 EP_NO: N/A Repair Type: No Action Needed Crossing Status: Found UCIP Comments: FIELD_STRUCT_DESC: 24-inch corrugated metal drainage pipe through the levee, 4.5 feet below the crown. Flap gate and concrete U-shaped headwall on the waterside (WS) end. Concrete U-shaped headwall on the landside (LS) end. [Additional Reference(s): DWR Levee Log, 1992. USACE Sacramento O&M Manual 510, April 1963, (HLM 0.39) Drawing No. 50-4-3622]. FS Date: 10/3/2013

Concrete U-shaped headwall on LS toe.

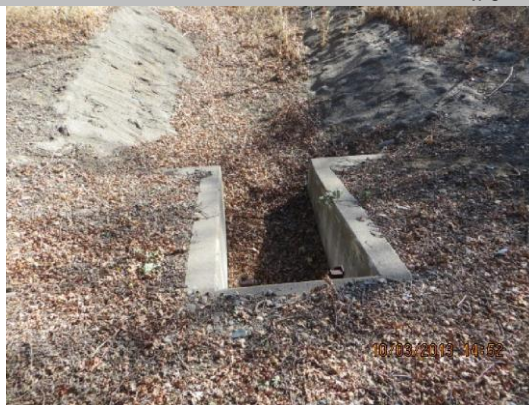
Photo 3 of 3 : UCIP_SP_2019_22826_38963.jpg

Concrete U-shaped headwall with concrete swale on WS toe.

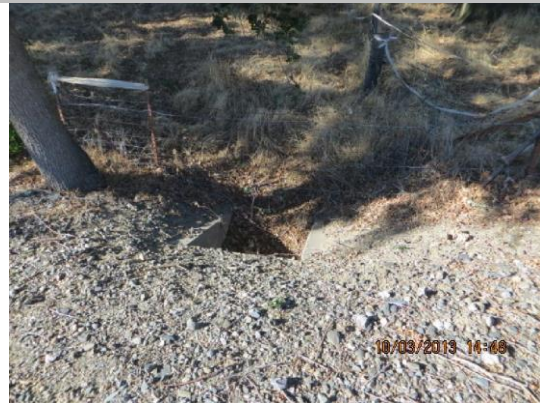
Photo 1 of 3 : UCIP_SP_2019_21793_37069.jpg

LM Start	0.51	Rating **	A/W	Issue No.	919
LM End	0.51	Issue Type +	Ma	Location *	
Category	Supplemental			GPS Latitude/Longitude	
				Start	End
Item	DWR UCIP LMA Responsibility			40.051211 °	40.051211 °
				-122.179663 °	-122.179663 °
DWR ID	20777				
Comment Code					
Inspector Comment					
FS_ID:21793					
DS_ID:20777					
EP_NO: N/A					
Repair Type: No Action Needed					
Crossing Status: Found					
UCIP Comments:					
FIELD_STRUCT_DESC: 24-inch corrugated metal drainage pipe through the levee, 5 feet below the crown. Flap gate and concrete U-shaped headwall on the waterside (WS) end. Concrete U-shaped headwall on the landside (LS) end. [Additional Reference(s): DWR Levee Log, 1992. USACE Sacramento O&M Manual 510, April 1963, (HLM 0.52) Drawing No. 50-4-3622].					
FS Date: 10/3/2013

Concrete U-shaped headwall on LS toe.

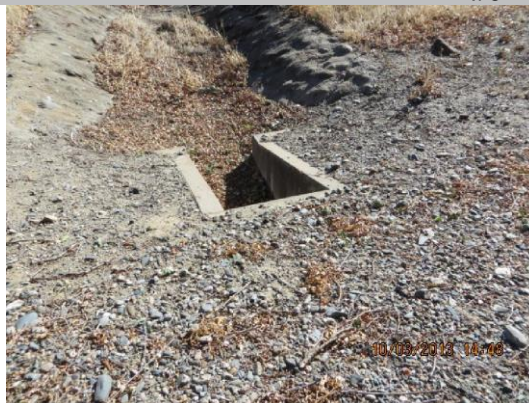
Photo 2 of 3 : UCIP_SP_2019_21793_37068.jpg

LM Start	0.51	Rating **	A/W	Issue No.	919 (cont)	
LM End	0.51	Issue Type +	Ma	Location *		
Category	Supplemental			GPS Latitude/Longitude		
				Start		End
Item	DWR UCIP LMA Responsibility			40.051211 °	40.051211 °	
				-122.179663 °	-122.179663 °	
DWR ID	20777					
Comment Code						
Inspector Comment						
FS_ID:21793 DS_ID:20777 EP_NO: N/A Repair Type: No Action Needed Crossing Status: Found UCIP Comments: FIELD_STRUCT_DESC: 24-inch corrugated metal drainage pipe through the levee, 5 feet below the crown. Flap gate and concrete U-shaped headwall on the waterside (WS) end. Concrete U-shaped headwall on the landside (LS) end. [Additional Reference(s): DWR Levee Log, 1992. USACE Sacramento O&M Manual 510, April 1963, (HLM 0.52) Drawing No. 50-4-3622]. FS Date: 10/3/2013

Concrete U-shaped headwall on WS toe.

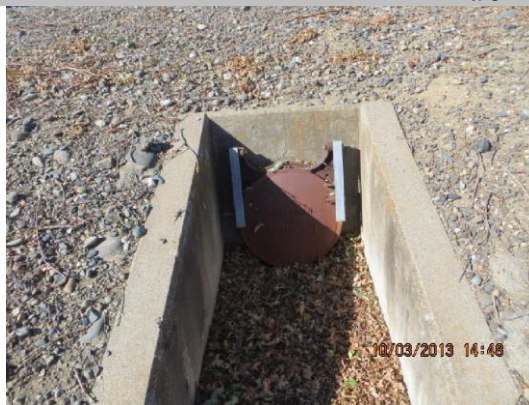
Photo 3 of 3 : UCIP_SP_2019_21793_37067.jpg

Concrete U-shaped headwall and flapgate on WS toe.

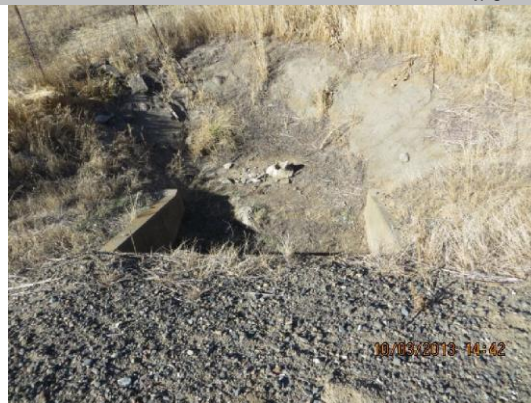
Photo 1 of 3 : UCIP_SP_2019_21792_37065.jpg

LM Start	0.64	Rating **	A/W	Issue No.	920
LM End	0.64	Issue Type +	Ma	Location *	
Category	Supplemental			GPS Latitude/Longitude	
				Start	End
Item	DWR UCIP LMA Responsibility			40.051699 °	40.051699 °
				-122.177320 °	-122.177320 °
DWR ID	20778				
Comment Code					
Inspector Comment					
FS_ID:21792					
DS_ID:20778					
EP_NO: N/A					
Repair Type: No Action Needed					
Crossing Status: Found					
UCIP Comments:					
FIELD_STRUCT_DESC: 1 of 2: 36-inch corrugated metal drainage pipe through the levee, 8.6 feet below the crown. Flap gate and concrete U-shaped headwall on the waterside (WS) end. Concrete U-shaped headwall on the landside (LS) end. [Additional Reference(s): DWR Levee Log, 1992. USACE Sacramento O&M Manual 510, April 1963, (HLM 0.65) Drawing No. 50-4-3622].					
FS Date: 10/3/2013

Concrete U-shaped headwall on LS toe.

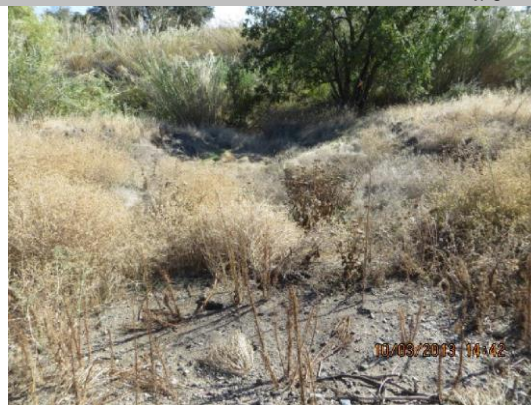
Photo 2 of 3 : UCIP_SP_2019_21792_37064.jpg

Concrete U-shaped headwall on WS toe.

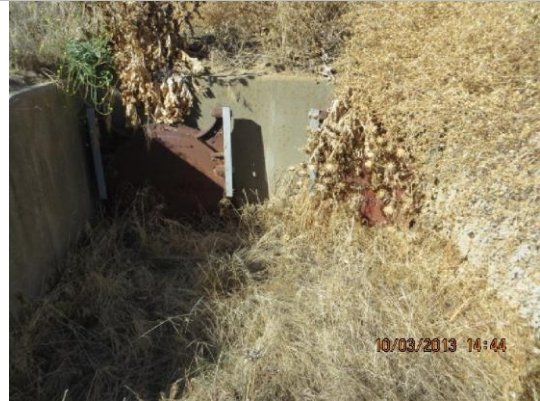
Photo 3 of 3 : UCIP_SP_2019_21792_37063.jpg

LM Start	0.64	Rating **	A/W	Issue No.	920 (cont)	
LM End	0.64	Issue Type +	Ma	Location *		
Category	Supplemental			GPS Latitude/Longitude		
				Start	End	
Item	DWR UCIP LMA Responsibility			40.051699 °	40.051699 °	
				-122.177320 °	-122.177320 °	
DWR ID	20778					
Comment Code						
Inspector Comment						
FS_ID:21792						
DS_ID:20778						
EP_NO: N/A						
Repair Type: No Action Needed						
Crossing Status: Found						
UCIP Comments:						
FIELD_STRUCT_DESC: 1 of 2: 36-inch corrugated metal drainage pipe through the levee, 8.6 feet below the crown. Flap gate and concrete U-shaped headwall on the waterside (WS) end. Concrete U-shaped headwall on the landside (LS) end. [Additional Reference(s): DWR Levee Log, 1992. USACE Sacramento O&M Manual 510, April 1963, (HLM 0.65) Drawing No. 50-4-3622].						
FS Date: 10/3/2013

Concrete U-shaped headwall and flapgate on WS toe.

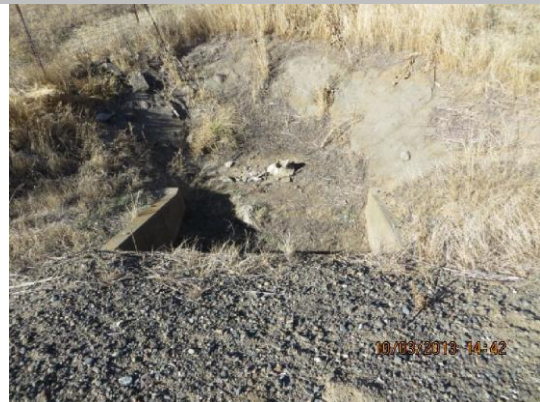
Photo 1 of 3 : UCIP_SP_2019_51443_37061.jpg

LM Start	0.64	Rating **	M	Issue No.	921
LM End	0.64	Issue Type +	Ma	Location *	
Category	Supplemental			GPS Latitude/Longitude	
				Start	End
Item	DWR UCIP LMA Responsibility			40.051702 °	40.051702 °
				-122.177308 °	-122.177308 °
DWR ID	20880

Comment Code					
Inspector Comment					
FS_ID:51443 DS_ID:20880 EP_NO: N/A Repair Type: Non-Urgent Crossing Status: Found UCIP Comments: 12/05/2016 Crossing has been downgraded from Urgent to Non-Urgent vegetation found on WS but does not appear to prevent proper function of flap gate. Recommend clearing dry vegetation on WS above concrete headwall.(O. Magana - DWR UCIP)10/03/2013 Flapgate operation hindered by soil and vegetation on WS toe. (W. Wylie - DWR UCIP) FIELD_STRUCT_DESC: 2 of 2: 36-inch corrugated metal drainage pipe through levee, 8.6 feet below crown. Flap gate and concrete "U" headwall located on the waterside (WS) end. Concrete "U" headwall located on the landside (LS) end. [Additional Reference(s): DWR Levee Log, 1992. USACE Sacramento O&M Manual, Unit 510, April 1963, As-built drawing No. 50-4-3622 (HLM 0.65)] FS Date: 12/5/2016

Concrete U-shaped headwall on LS toe.

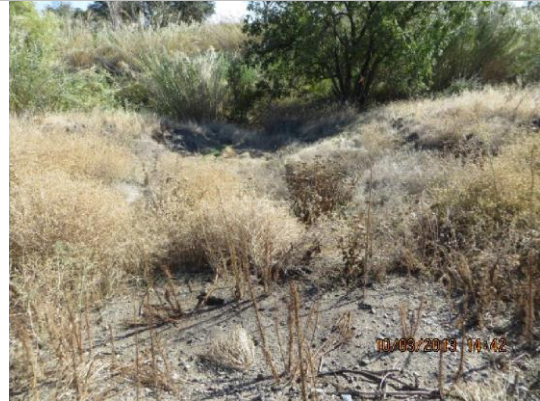
Photo 2 of 3 : UCIP_SP_2019_51443_37060.jpg

Comment Code						
Inspector Comment						
FS_ID:51443 DS_ID:20880 EP_NO: N/A Repair Type: Non-Urgent Crossing Status: Found UCIP Comments: 12/05/2016 Crossing has been downgraded from Urgent to Non-Urgent vegetation found on WS but does not appear to prevent proper function of flap gate. Recommend clearing dry vegetation on WS above concrete headwall.(O. Magana - DWR UCIP)10/03/2013 Flapgate operation hindered by soil and vegetation on WS toe. (W. Wylie - DWR UCIP) FIELD_STRUCT_DESC: 2 of 2: 36-inch corrugated metal drainage pipe through levee, 8.6 feet below crown. Flap gate and concrete "U" headwall located on the waterside (WS) end. Concrete "U" headwall located on the landside (LS) end. [Additional Reference(s): DWR Levee Log, 1992. USACE Sacramento O&M Manual, Unit 510, April 1963, As-built drawing No. 50-4-3622 (HLM 0.65)] FS Date: 12/5/2016

Concrete U-shaped headwall on WS toe.

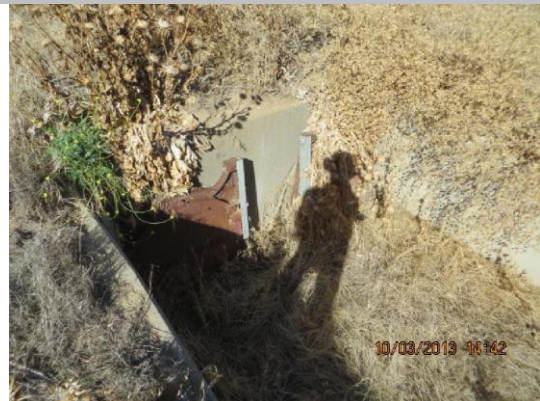
Photo 3 of 3 : UCIP_SP_2019_51443_37059.jpg

Concrete U-shaped headwall and flapgate on WS toe.

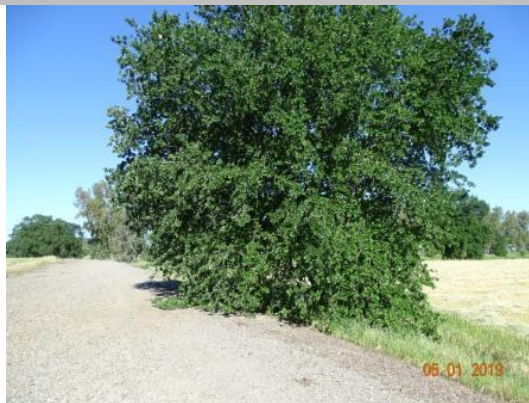
Photo 1 of 1 : SP_2019_NA0019_81_58_20190506_00080.jpg

LM Start	0.68	Rating **	M	Issue No.	58
LM End	0.68	Issue Type +	Ma	Location *	LS
Category	Earthen Levee			GPS Latitude/Longitude	
				Start	End
Item	Trim / Thin Trees			40.051719 °	40.051719 °
				-122.176629 °	-122.176629 °
DWR ID	DWR_NA0019_04_s_2019_58				
Comment Code					
T1 : Trim trees to at least five feet above ground level.					
Inspector Comment

View of the tree blocking visibility of the landside slope and toe. Spring 2019.

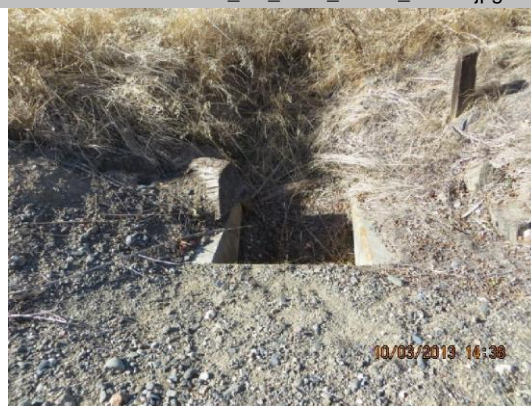
Photo 1 of 3 : UCIP_SP_2019_21790_37057.jpg

LM Start	0.75	Rating **	A/W	Issue No.	922	
LM End	0.75	Issue Type +	Ma	Location *		
Category	Supplemental			GPS Latitude/Longitude		
				Start	End	
Item	DWR UCIP LMA Responsibility			40.052194 °	40.052194 °	
				-122.175390 °	-122.175390 °	
DWR ID	20779					
Comment Code						
Inspector Comment						
FS_ID:21790 DS_ID:20779 EP_NO: N/A Repair Type: No Action Needed Crossing Status: Found UCIP Comments: FIELD_STRUCT_DESC: 24-inch corrugated metal drainage pipe through the levee, 5.8 feet below the crown. Flap gate and concrete U-shaped headwall on the waterside (WS) end. Concrete U-shaped headwall on the landside (LS) end. [Additional Reference(s): DWR Levee Log, 1992. USACE Sacramento O&M Manual 510, April 1963, (HLM 0.76) Drawing No. 50-4-3622]. FS Date: 10/3/2013

Concrete U-shaped headwall on LS toe.

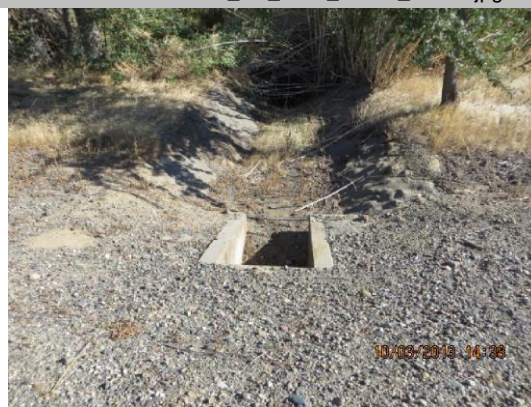
Photo 2 of 3 : UCIP_SP_2019_21790_37056.jpg

Concrete U-shaped headwall on WS toe.

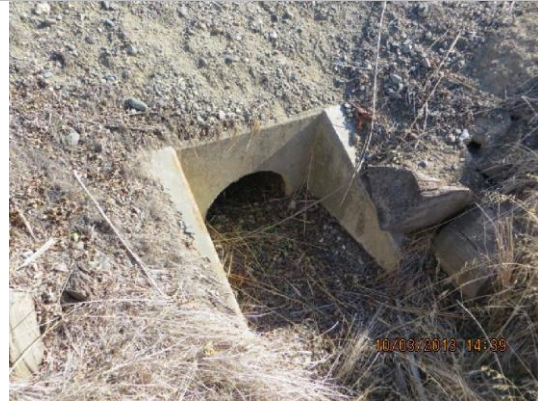
Photo 3 of 3 : UCIP_SP_2019_21790_37055.jpg

LM Start	0.75	Rating **	A/W	Issue No.	922 (cont)	
LM End	0.75	Issue Type +	Ma	Location *		
Category	Supplemental			GPS Latitude/Longitude		
				Start	End	
Item	DWR UCIP LMA Responsibility			40.052194 °	40.052194 °	
				-122.175390 °	-122.175390 °	
DWR ID	20779					
Comment Code						
Inspector Comment						
FS_ID:21790 DS_ID:20779 EP_NO: N/A Repair Type: No Action Needed Crossing Status: Found UCIP Comments: FIELD_STRUCT_DESC: 24-inch corrugated metal drainage pipe through the levee, 5.8 feet below the crown. Flap gate and concrete U-shaped headwall on the waterside (WS) end. Concrete U-shaped headwall on the landside (LS) end. [Additional Reference(s): DWR Levee Log, 1992. USACE Sacramento O&M Manual 510, April 1963, (HLM 0.76) Drawing No. 50-4-3622]. FS Date: 10/3/2013

Concrete U-shaped headwall on LS toe.

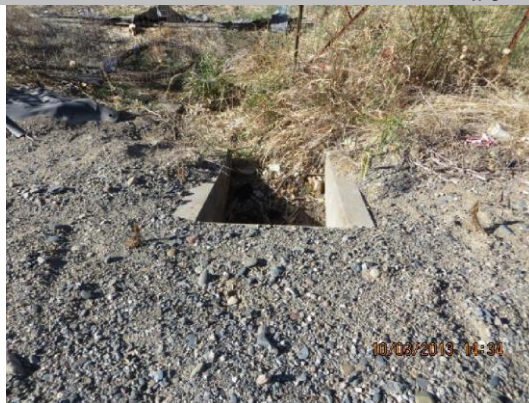
Photo 1 of 3 : UCIP_SP_2019_22827_38970.jpg

LM Start	0.91	Rating **	A/W	Issue No.	923
LM End	0.91	Issue Type +	Ma	Location *	
Category	Supplemental			GPS Latitude/Longitude	
				Start	End
Item	DWR UCIP LMA Responsibility			40.053401 °	40.053401 °
				-122.172848 °	-122.172848 °
DWR ID	20780				
Comment Code					
Inspector Comment					
FS_ID:22827					
DS_ID:20780					
EP_NO: N/A					
Repair Type: No Action Needed					
Crossing Status: Found					
UCIP Comments:					
FIELD_STRUCT_DESC: 24-inch corrugated metal drainage pipe through the levee, 4.5 feet below the crown. Flap gate and concrete U-shaped headwall on the waterside (WS) end. Concrete U-shaped headwall on the landside (LS) end. [Additional Reference(s): DWR Levee Log, 1992. USACE Sacramento O&M Manual 510, April 1963, (HLM 0.93) Drawing No. 50-4-3622].					
FS Date: 10/3/2013

Concrete U-shaped headwall on LS toe.

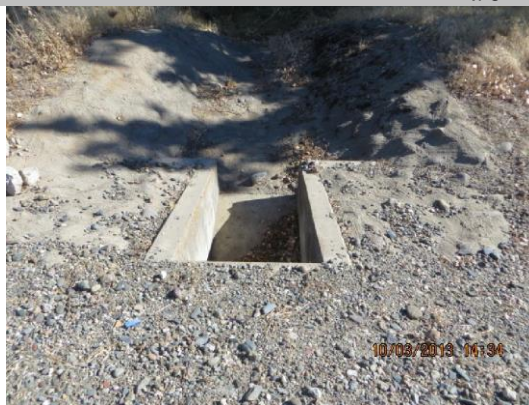
Photo 2 of 3 : UCIP_SP_2019_22827_38969.jpg

Concrete U-shaped headwall on WS toe.

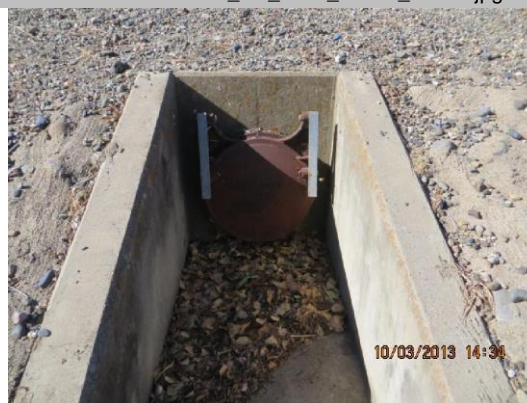
Photo 3 of 3 : UCIP_SP_2019_22827_38972.jpg

LM Start	0.91	Rating **	A/W	Issue No.	923 (cont)	
LM End	0.91	Issue Type +	Ma	Location *		
Category	Supplemental			GPS Latitude/Longitude		
				Start		End
Item	DWR UCIP LMA Responsibility			40.053401 °		40.053401 °
				-122.172848 °		-122.172848 °
DWR ID	20780					
Comment Code						
Inspector Comment						
FS_ID:22827						
DS_ID:20780						
EP_NO: N/A						
Repair Type: No Action Needed						
Crossing Status: Found						
UCIP Comments:						
FIELD_STRUCT_DESC: 24-inch corrugated metal drainage pipe through the levee, 4.5 feet below the crown. Flap gate and concrete U-shaped headwall on the waterside (WS) end. Concrete U-shaped headwall on the landside (LS) end. [Additional Reference(s): DWR Levee Log, 1992. USACE Sacramento O&M Manual 510, April 1963, (HLM 0.93) Drawing No. 50-4-3622].						
FS Date: 10/3/2013

Flapgate on headwall at WS toe.

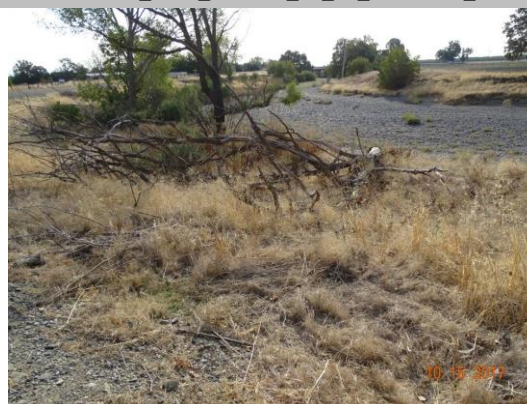
Photo 1 of 1 : SP_2019_NA0019_81_50_20190327_00023.jpg

LM Start	0.92	Rating **	M	Issue No.	50
LM End	0.92	Issue Type +	Ma	Location *	WS
Category	Earthen Levee			GPS Latitude/Longitude	
				Start	End
Item	Encroachments			40.053420 °	40.053420 °
				-122.172617 °	-122.172617 °
DWR ID	DWR_NA0019_04_f_2017_50				
Comment Code					
TR : Tree or limb					
Inspector Comment					
Remove the downed tree from the waterside toe.

View of the tree along waterside toe.

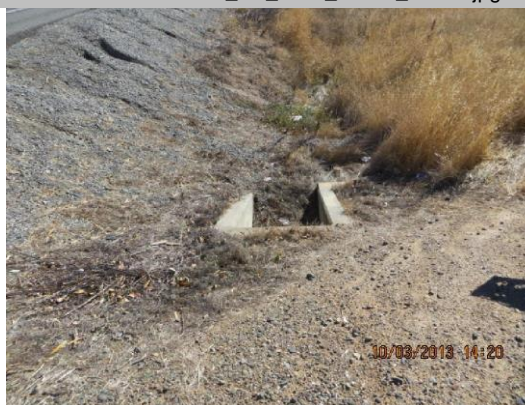
Photo 1 of 3 : UCIP_SP_2019_21788_37050.jpg

LM Start	1.07	Rating **	A/W	Issue No.	924
LM End	1.07	Issue Type +	Ma	Location *	
Category	Supplemental			GPS Latitude/Longitude	
				Start	End
Item	DWR UCIP LMA Responsibility			40.052400 °	40.052400 °
				-122.170279 °	-122.170279 °
DWR ID	20790				
Comment Code					
Inspector Comment					
FS_ID:21788 DS_ID:20790 EP_NO: N/A Repair Type: No Action Needed Crossing Status: Found UCIP Comments: FIELD_STRUCT_DESC: 24-inch corrugated metal drainage pipe through the levee, 5 feet below the crown. Flap gate and concrete U-shaped headwall on the waterside (WS) end. Concrete U-shaped headwall on the landside (LS) end. [Additional Reference(s): DWR Levee Log, 1992. USACE Sacramento O&M Manual 510, April 1963, (HLM 1.10) Drawing No. 50-4-3622]. FS Date: 10/3/2013

Concrete U-shaped headwall on WS toe.

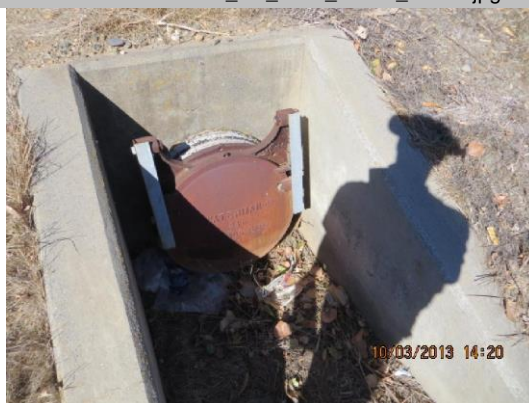
Photo 2 of 3 : UCIP_SP_2019_21788_37053.jpg

LM Start	1.07	Rating **	A/W	Issue No.	924 (cont)	
LM End	1.07	Issue Type +	Ma	Location *		
Category	Supplemental			GPS Latitude/Longitude		
				Start		End
Item	DWR UCIP LMA Responsibility			40.052400 °		40.052400 °
				-122.170279 °		-122.170279 °
DWR ID	20790					
Comment Code						
Inspector Comment						
FS_ID:21788 DS_ID:20790 EP_NO: N/A Repair Type: No Action Needed Crossing Status: Found UCIP Comments: FIELD_STRUCT_DESC: 24-inch corrugated metal drainage pipe through the levee, 5 feet below the crown. Flap gate and concrete U-shaped headwall on the waterside (WS) end. Concrete U-shaped headwall on the landside (LS) end. [Additional Reference(s): DWR Levee Log, 1992. USACE Sacramento O&M Manual 510, April 1963, (HLM 1.10) Drawing No. 50-4-3622]. FS Date: 10/3/2013

Concrete U-shaped headwall and flapgate on WS toe.

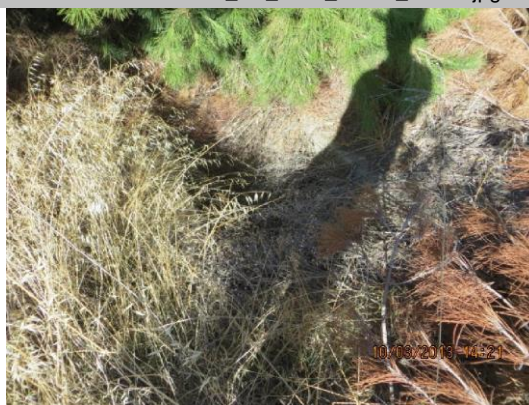
Photo 3 of 3 : UCIP_SP_2019_21788_37052.jpg

Concrete U-shaped headwall on LS toe.

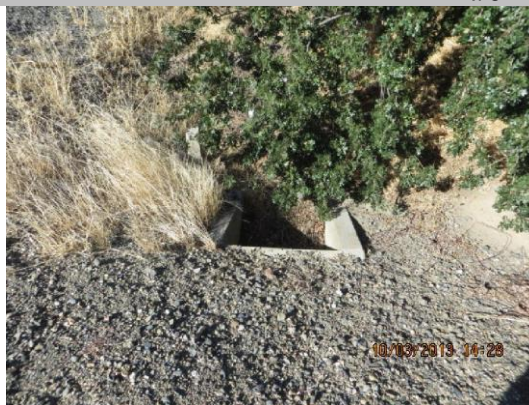
Photo 2 of 2 : UCIP_SP_2019_21786_37047.jpg

Concrete U-shaped headwall on LS toe.

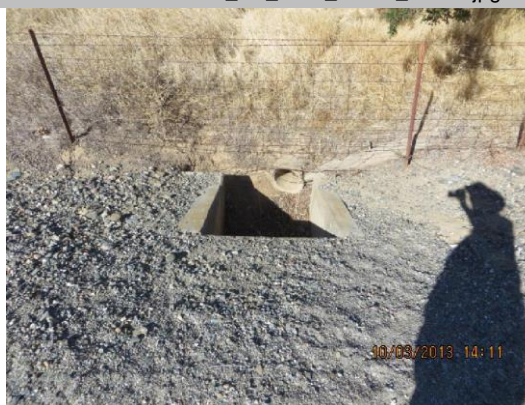
Photo 1 of 3 : UCIP_SP_2019_21778_37037.jpg

LM Start	1.30	Rating **	A/W	Issue No.	926
LM End	1.30	Issue Type +	Ma	Location *	
Category	Supplemental			GPS Latitude/Longitude	
				Start	End
Item	DWR UCIP LMA Responsibility			40.051563 °	40.051563 °
				-122.166630 °	-122.166630 °
DWR ID	20782				
Comment Code					
Inspector Comment					
FS_ID:21778					
DS_ID:20782					
EP_NO: N/A					
Repair Type: No Action Needed					
Crossing Status: Found					
UCIP Comments:					
FIELD_STRUCT_DESC: 24-inch corrugated metal drainage pipe through the levee, 4.5 feet below the crown. Flap gate and concrete U-shaped headwall on the waterside (WS) end. Concrete U-shaped headwall on the landside (LS) end. [Additional Reference(s): DWR Levee Log, 1992. USACE Sacramento O&M Manual 510, April 1963, (HLM 1.30) Drawing No. 50-4-3622].					
FS Date: 10/3/2013

Concrete U-shaped headwall on LS toe.

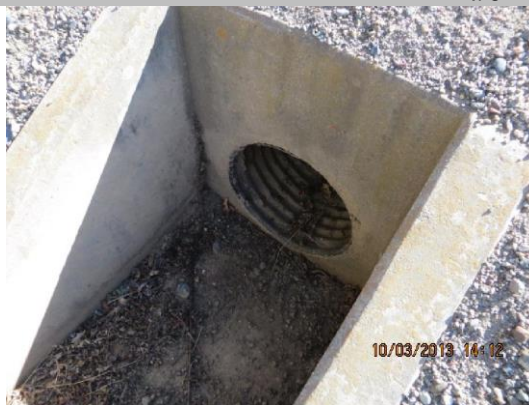
Photo 3 of 3 : UCIP_SP_2019_21778_37035.jpg

Concrete U-shaped headwall on LS toe.

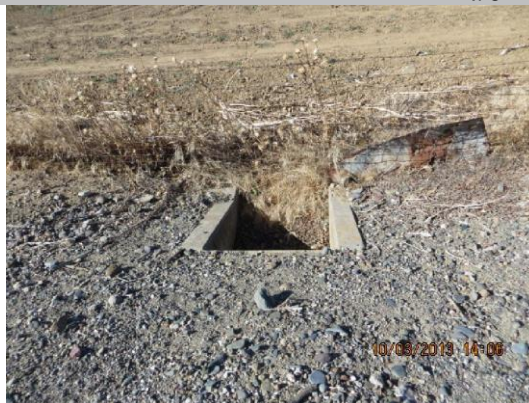
Photo 1 of 3 : UCIP_SP_2019_21776_37029.jpg

LM Start	1.56	Rating **	A/W	Issue No.	927
LM End	1.56	Issue Type +	Ma	Location *	
Category	Supplemental			GPS Latitude/Longitude	
				Start	End
Item	DWR UCIP LMA Responsibility			40.052495 °	40.052495 °
				-122.161921 °	-122.161921 °
DWR ID	20783				
Comment Code					
Inspector Comment					
FS_ID:21776 DS_ID:20783 EP_NO: N/A Repair Type: No Action Needed Crossing Status: Found UCIP Comments: FIELD_STRUCT_DESC: 24-inch corrugated metal drainage pipe through the levee, 5.8 feet below the crown. Flap gate and concrete U-shaped headwall on the waterside (WS) end. Concrete U-shaped headwall on the landside (LS) end. [Additional Reference(s): DWR Levee Log, 1992. USACE Sacramento O&M Manual 510, April 1963, (HLM 1.57) Drawing No. 50-4-3622]. FS Date: 10/3/2013

Concrete U-shaped headwall on LS toe.

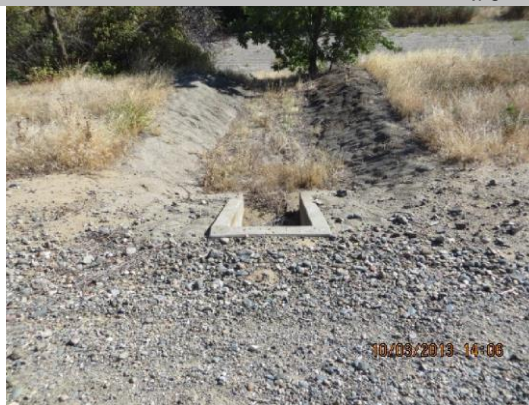
Photo 2 of 3 : UCIP_SP_2019_21776_37028.jpg

Concrete U-shaped headwall on WS toe.

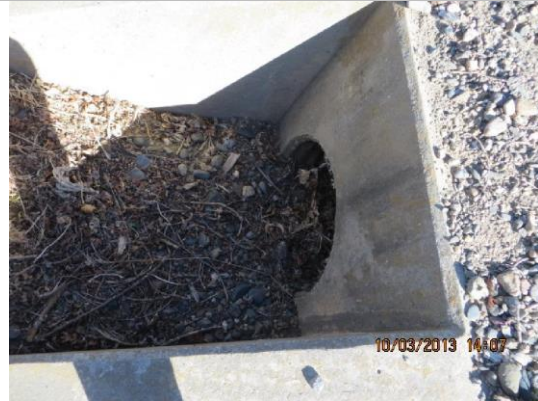
Photo 3 of 3 : UCIP_SP_2019_21776_37027.jpg

Concrete U-shaped headwall on LS toe.

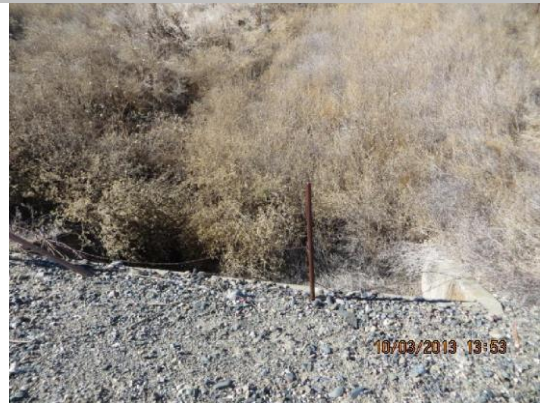
Photo 1 of 3 : UCIP_SP_2019_21769_37004.jpg

LM Start	1.69	Rating **	A/W	Issue No.	928
LM End	1.69	Issue Type +	Ma	Location *	
Category	Supplemental			GPS Latitude/Longitude	
				Start	End
Item	DWR UCIP LMA Responsibility			40.053590 °	40.053590 °
				-122.159982 °	-122.159982 °
DWR ID	20786				
Comment Code					
Inspector Comment					
FS_ID:21769					
DS_ID:20786					
EP_NO: N/A					
Repair Type: No Action Needed					
Crossing Status: Found					
UCIP Comments:					
FIELD_STRUCT_DESC: 1 of 3: 36-inch corrugated metal drainage pipe through the levee, 7.3 feet below the crown. Flap gate and concrete U-shaped headwall on the waterside (WS) end. Concrete U-shaped headwall on the landside (LS) end. [Additional Reference(s): DWR Levee Log, 1992. USACE Sacramento O&M Manual 510, April 1963, (HLM 1.70) Drawing No. 50-4-3622].					
FS Date: 10/3/2013

Concrete inlet on LS toe.

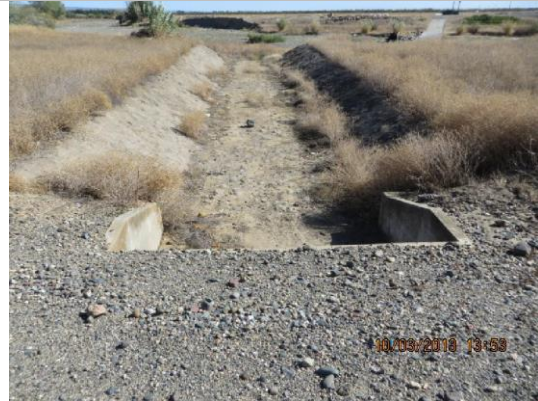
Photo 2 of 3 : UCIP_SP_2019_21769_37003.jpg

Concrete inlet on WS toe.

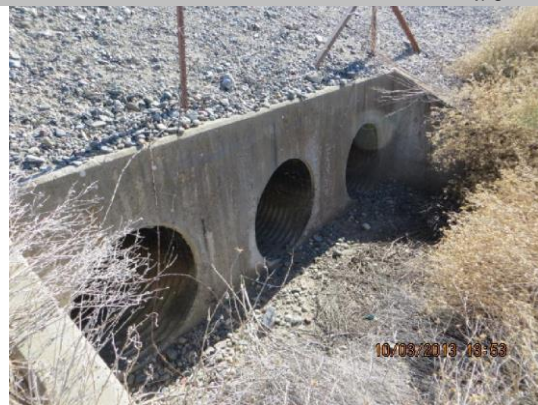
Photo 3 of 3 : UCIP_SP_2019_21769_37002.jpg

Concrete inlet on LS toe.

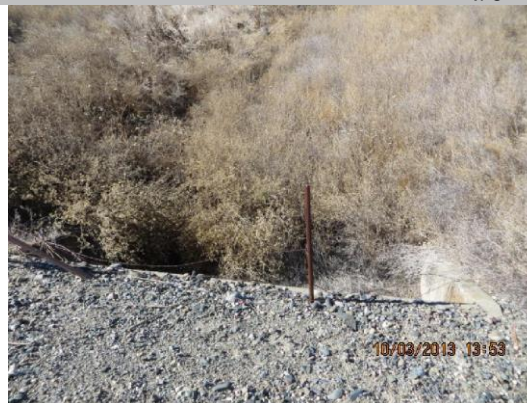
Photo 1 of 3 : UCIP_SP_2019_21768_37000.jpg

LM Start	1.69	Rating **	A/W	Issue No.	929
LM End	1.69	Issue Type +	Ma	Location *	
Category	Supplemental			GPS Latitude/Longitude	
				Start	End
Item	DWR UCIP LMA Responsibility			40.053601 °	40.053601 °
				-122.159966 °	-122.159966 °
DWR ID	20883				
Comment Code					
Inspector Comment					
FS_ID:21768 DS_ID:20883 EP_NO: N/A Repair Type: No Action Needed Crossing Status: Found UCIP Comments: FIELD_STRUCT_DESC: 2 of 3: 36-inch corrugated metal drainage pipe through the levee, 7.3 feet below the crown. Flap gate and concrete U-shaped headwall on the waterside (WS) end. Concrete U-shaped headwall on the landside (LS) end. [Additional Reference(s): DWR Levee Log, 1992. USACE Sacramento O&M Manual 510, April 1963, (HLM 1.70) Drawing No. 50-4-3622]. FS Date: 10/3/2013

Concrete headwall on LS toe.

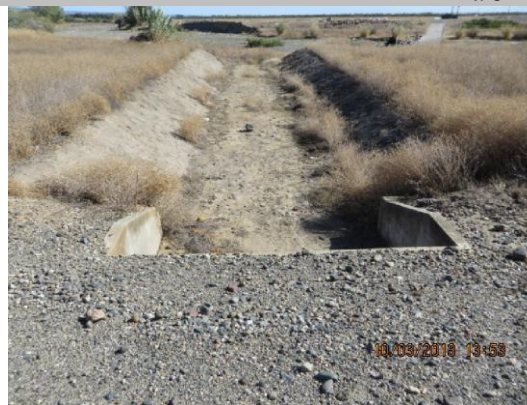
Photo 2 of 3 : UCIP_SP_2019_21768_36999.jpg

Concrete headwall on WS toe.

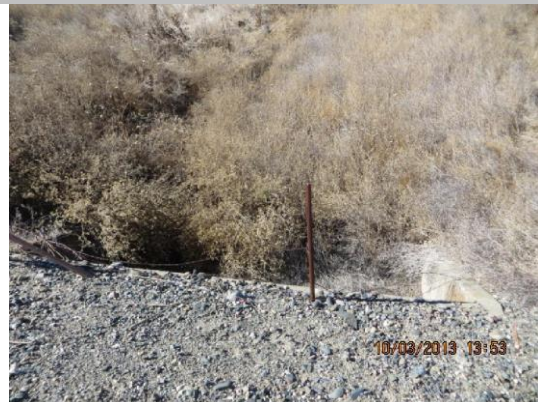
Photo 1 of 3 : UCIP_SP_2019_21767_36996.jpg

LM Start	1.69	Rating **	A/W	Issue No.	930
LM End	1.69	Issue Type +	Ma	Location *	
Category	Supplemental			GPS Latitude/Longitude	
				Start	End
Item	DWR UCIP LMA Responsibility			40.053614 °	40.053614 °
				-122.159956 °	-122.159956 °
DWR ID	20884				
Comment Code					
Inspector Comment					
FS_ID:21767					
DS_ID:20884					
EP_NO: N/A					
Repair Type: No Action Needed					
Crossing Status: Found					
UCIP Comments:					
FIELD_STRUCT_DESC: 3 of 3: 36-inch corrugated metal drainage pipe through the levee, 7.3 feet below the crown. Flap gate and concrete U-shaped headwall on the waterside (WS) end. Concrete U-shaped headwall on the landside (LS) end. [Additional Reference(s): DWR Levee Log, 1992. USACE Sacramento O&M Manual 510, April 1963, (HLM 1.70) Drawing No. 50-4-3622].					
FS Date: 10/3/2013

Concrete headwall on LS slope.

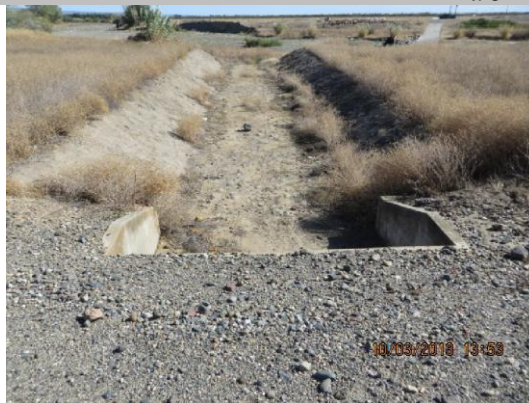
Photo 2 of 3 : UCIP_SP_2019_21767_36995.jpg

Concrete headwall on WS toe.

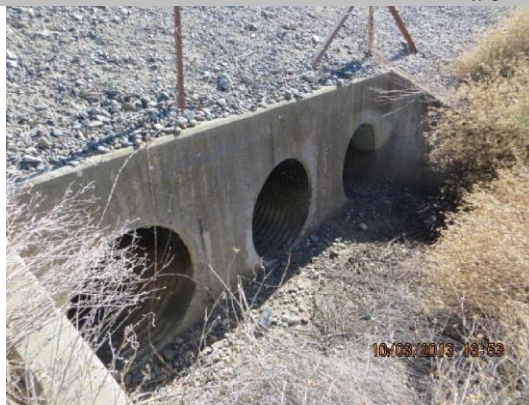
Photo 3 of 3 : UCIP_SP_2019_21767_36994.jpg

Concrete headwall on LS toe.

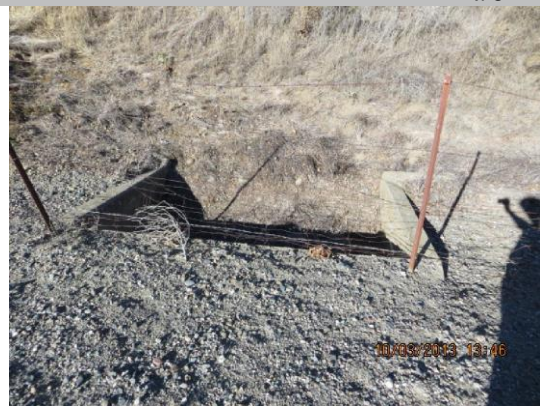
Photo 1 of 3 : UCIP_SP_2019_21766_36992.jpg

LM Start	1.99	Rating **	A/W	Issue No.	931
LM End	1.99	Issue Type +	Ma	Location *	
Category	Supplemental			GPS Latitude/Longitude	
				Start	End
Item	DWR UCIP LMA Responsibility			40.052731 °	40.052731 °
				-122.154695 °	-122.154695 °
DWR ID	20787				
Comment Code					
Inspector Comment					
FS_ID:21766 DS_ID:20787 EP_NO: N/A Repair Type: No Action Needed Crossing Status: Found UCIP Comments: FIELD_STRUCT_DESC: 1 of 2: 36-inch corrugated metal drainage pipe through the levee, 7.6 feet below the crown. Flap gate and concrete U-shaped headwall on the waterside (WS) end. Concrete U-shaped headwall on the landside (LS) end. [Additional Reference(s): DWR Levee Log, 1992. USACE Sacramento O&M Manual 510, April 1963, (HLM 2.01) Drawing No. 50-4-3622]. FS Date: 10/3/2013

Concrete headwall on LS toe.

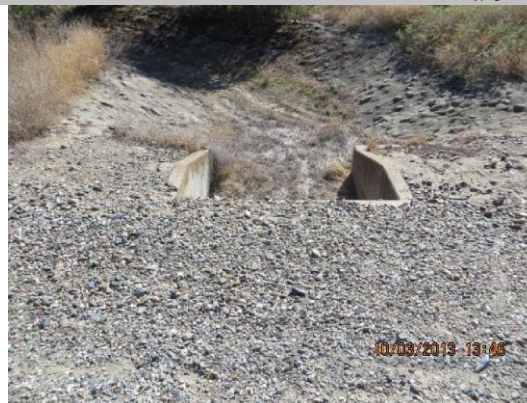
Photo 2 of 3 : UCIP_SP_2019_21766_36991.jpg

Concrete headwall on WS toe.
